June 2002

Technical Series 02-100

FINAL ASSESSMENT OF CONSERVATION CO-OP'S GREYWATER SYSTEM

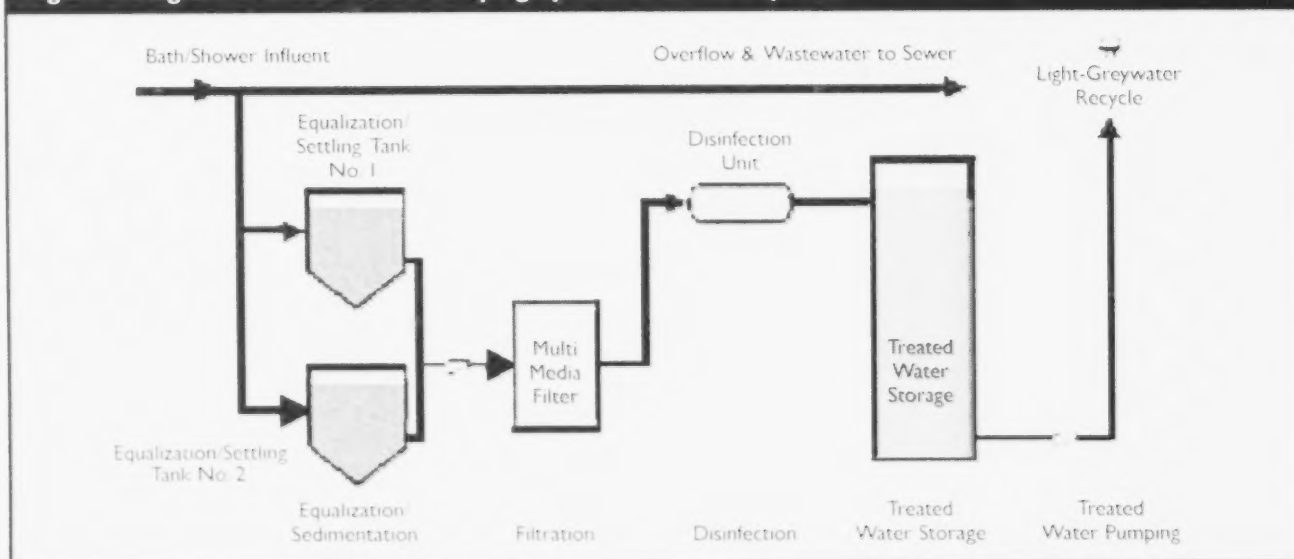
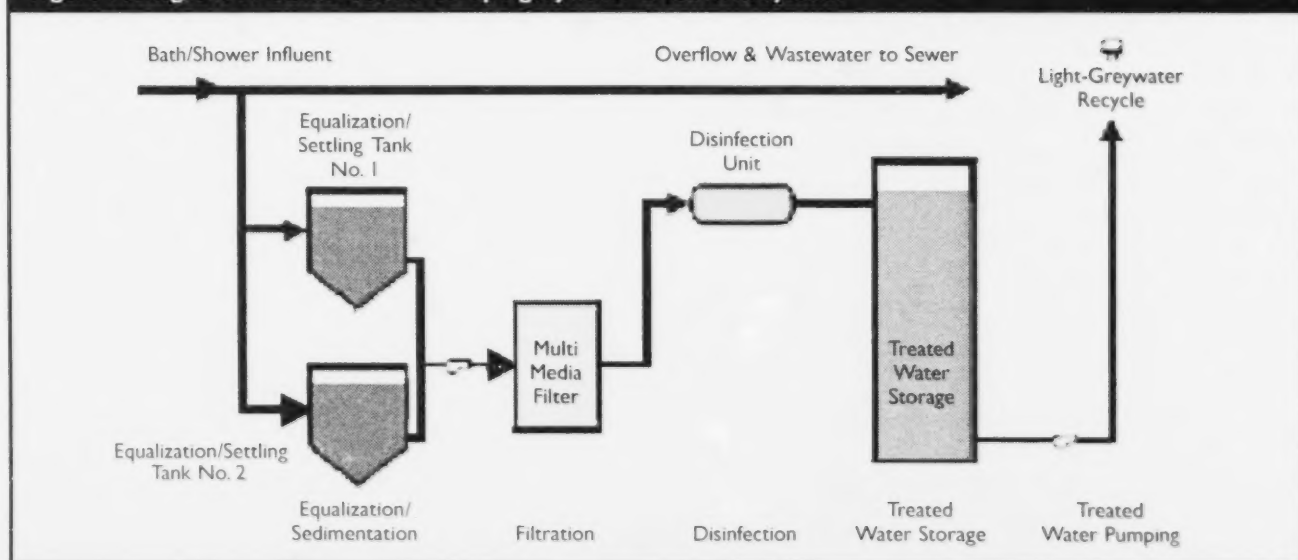
Figure 1: Diagram of Conservation Co-op's greywater treatment system

- *distribution pump* - When a toilet was flushed, the resulting drop in water pressure within the distribution system was sensed, and a 0.75 hp distribution pump was activated to provide reused water to the toilet. Although the pump might have been able to supply adequate pressure and flow of water to a single toilet, it could not adequately meet the demands of multiple toilets flushing simultaneously, hence the need for residents to flush toilets repeatedly. This pump may have been the source of "banging" noises reported by the residents.

Although an intermittent sand filter (ISF) can effectively remove BOD from wastewater, the slow sand filter and rapid sand filters tested in this project were ineffective for this purpose. They are more appropriate for filtering particulate material in potable water treatment applications. The multimedia pressure filter installed as part of the final treatment system was even less likely to reduce BOD.

1. Add a biological treatment component to the process, in place of the multimedia filter, to reduce BOD concentration from 130 mg/L to less than 10 mg/L. NovaTec recommended an Orenco AdvanTex AX10 treatment system, given the restricted area available for biological treatment. This system is unique in terms of its small size (8' x 6' room) and simplicity of operation, in comparison to more conventional methods of biological treatment.

2. Add a pressure tank to the system to provide water to the reuse water distribution system. The existing distribution pump would transfer water from the treated water tank to the pressure tank, which would be sized to provide adequate flow/pressure to accommodate up to six toilets flushed simultaneously. The pressure tank would also significantly reduce or effectively eliminate any "banging" noise.

3. Replace the ozonation system with either a secondary chlorination or ultraviolet disinfection system to ensure that faecal coliform levels in the treated water are less than 2.2 MPN/100 mL (i.e., non-detectable). This would eliminate the hazardous conditions associated with ozone being ventilated into an equipment room or a basement area. While a chlorination system is less expensive and simpler to operate and maintain than an ultraviolet disinfection system, it may be less acceptable, as the smell of chlorine may be objectionable to some people.
